## Advisory Visit River Penk, Perton (Revisit 2021)

Advisory Visit by Paul Gaskell (pgaskell@wildtrout.org)

12/10/2021

<b>River</b>	River Penk
<b>Waterbody Name</b>	River Penk from source to the Saredon Brook
<b>Waterbody ID</b>	<b>GB104028046680</b>
<b>Management Catchment</b>	Trent Valley Staffordshire
<b>River Basin District</b>	Humber
<b>Current Ecological Quality</b>	Poor
<b>U/S Grid Ref inspected</b>	S08733299653
<b>D/S Grid Ref inspected</b>	SJ8593500118
<b>Length of river inspected</b>	1.8 km

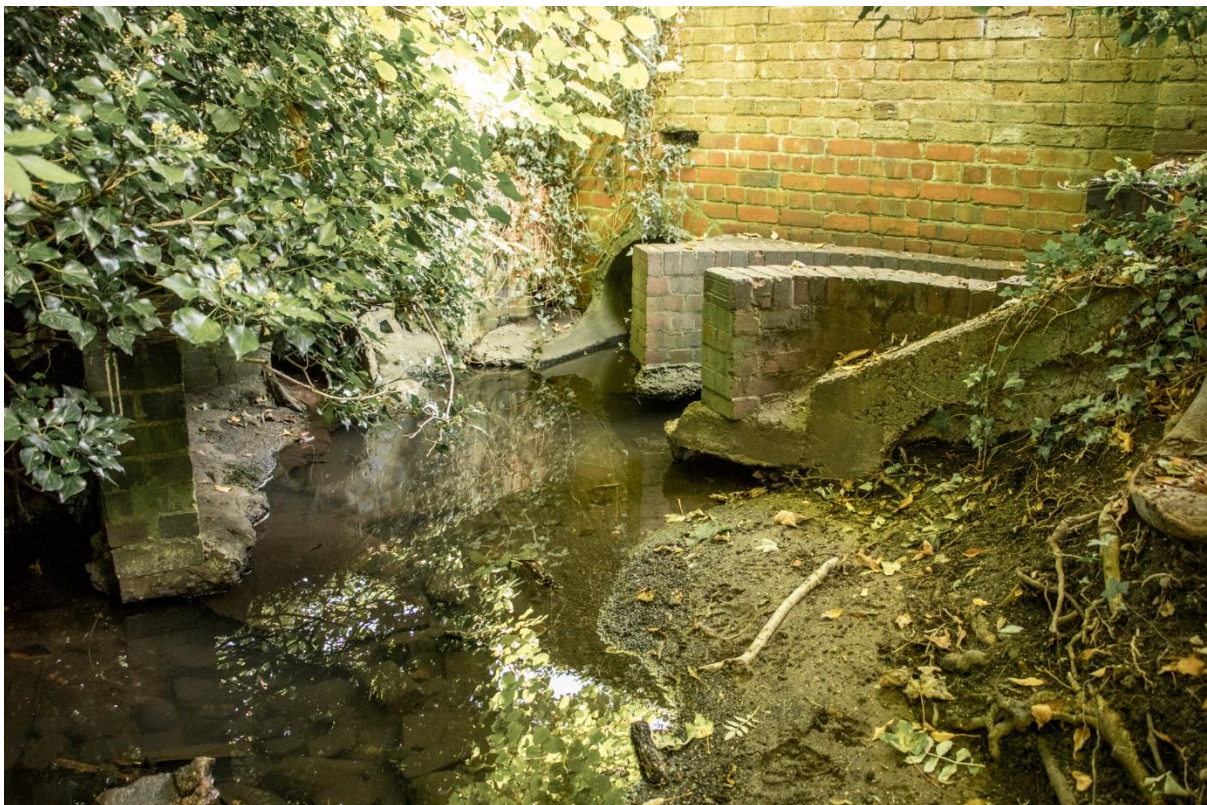
Figure 1: River Penk emerging from beneath Yew Tree Lane road bridge.

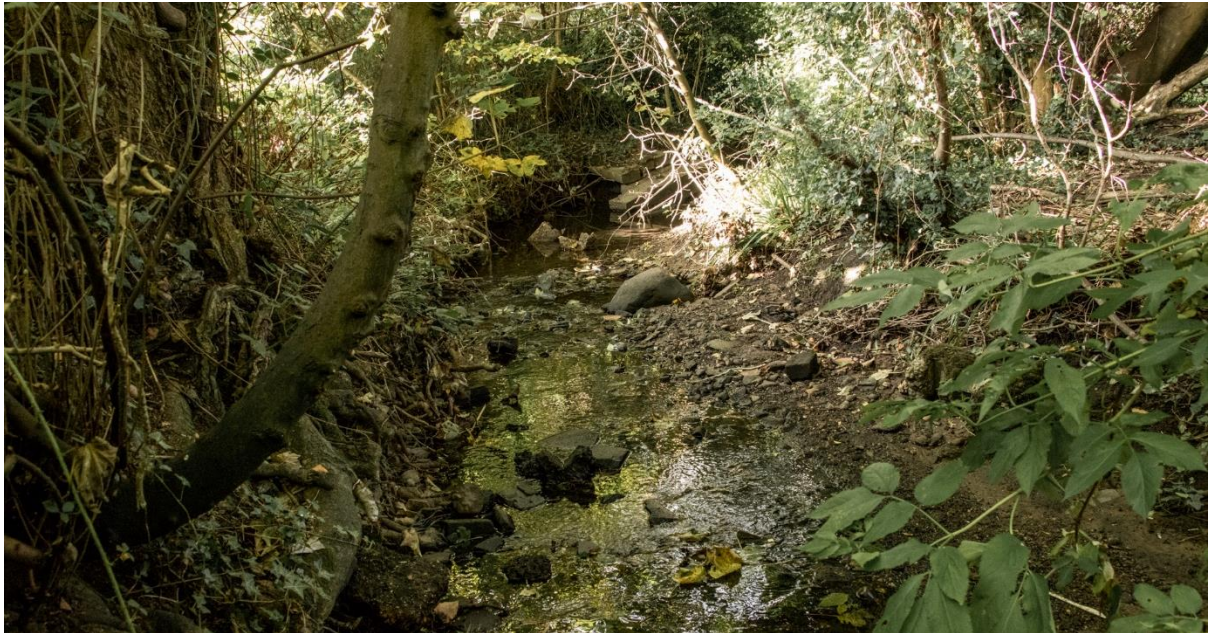
records very high numbers of *Gammarus* (freshwater shrimp) and also some *Baetis* (olive mayfly) larvae as stand-out observations. The tree canopy (Fig. 2) will be an important source of leaf-litter for the *Gammarus* – given their status as important stream detritivores.

Figure 2: As well as deciduous leaf-litter, areas of dense tree canopy provide important cool-water refuge habitat for small, shallow streams during warm weather.

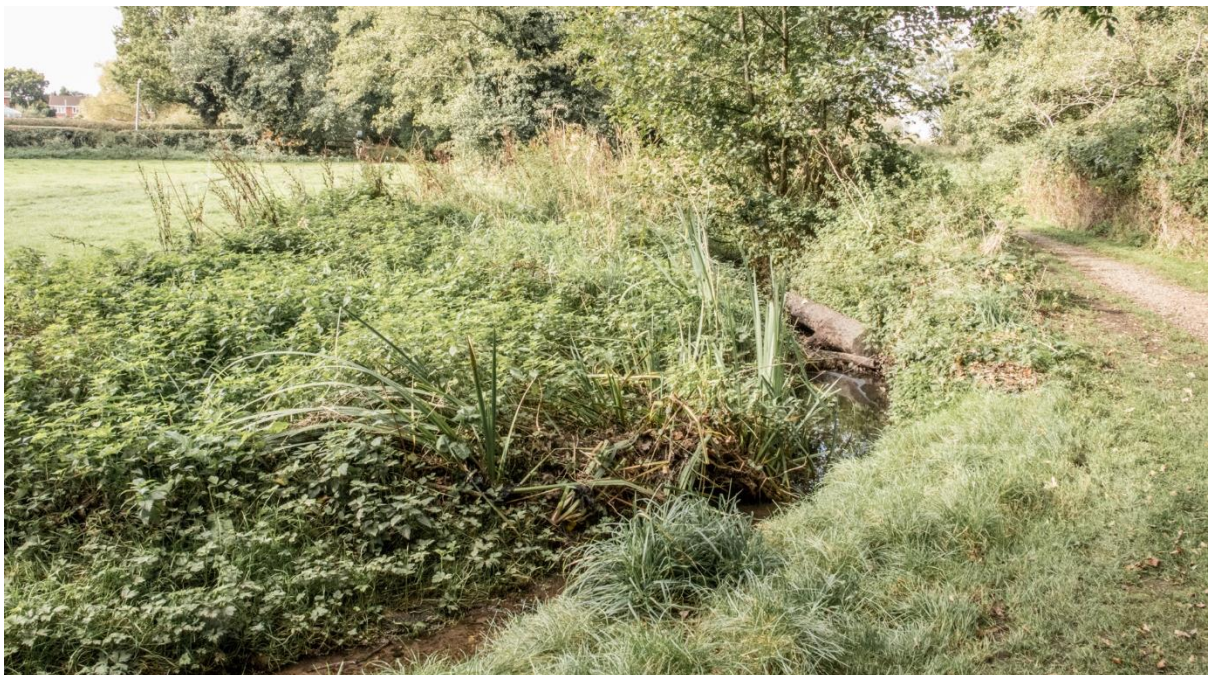
Figure 3: Unmown buffer strip with some supportive planting of riparian vegetation. Prominence of nettles is consistent with elevated nitrate levels.

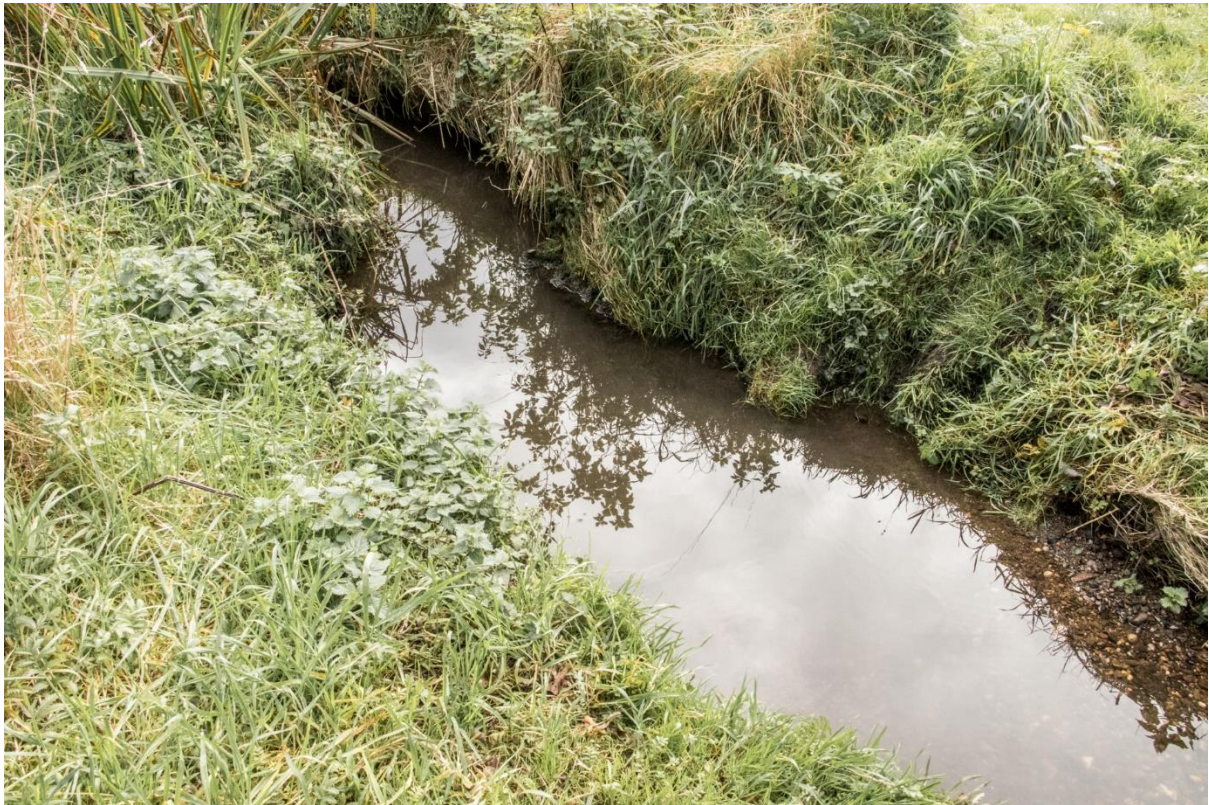
Examples of habitat potentially suitable to gravel-spawning species were noted at SO8717799729 (Figs. 4 and 5).

Figure 4: Small scour-pool created by the pinch-point maintained by vegetation-consolidated banks

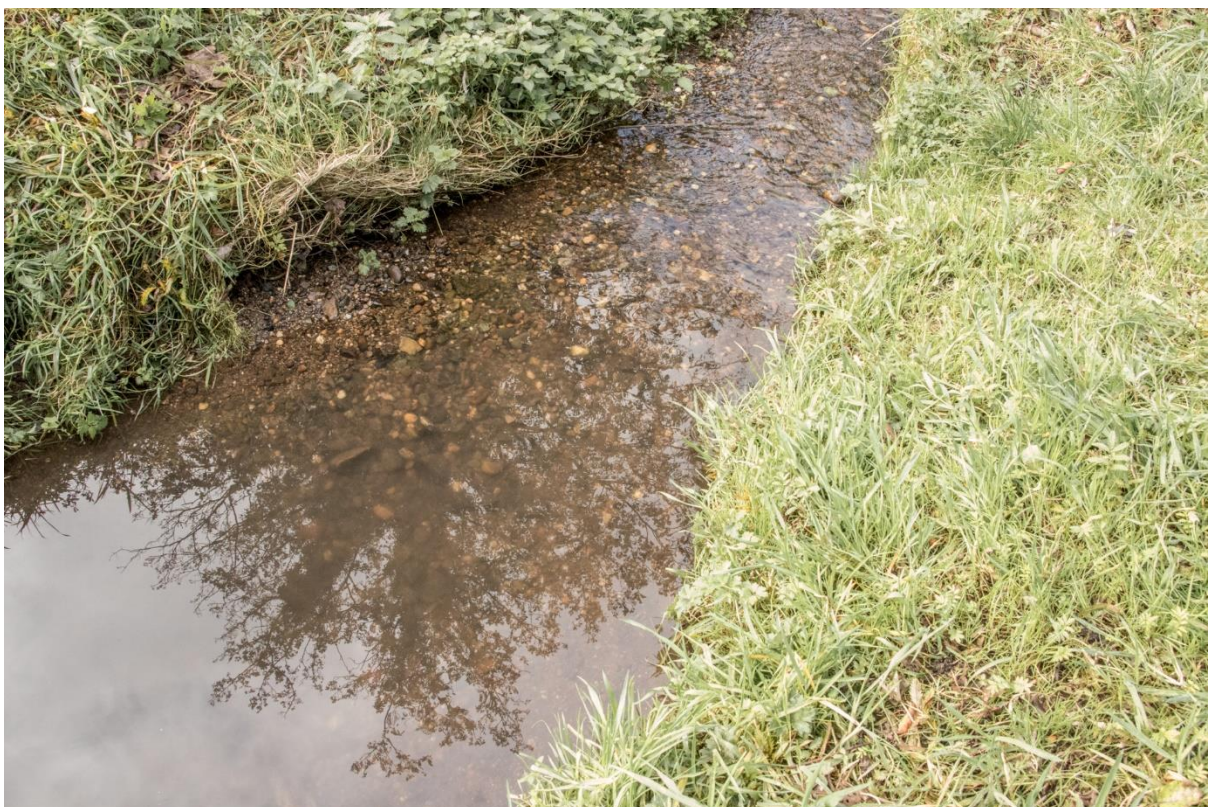
Figure 5: Gravel deposit arising from localised bed-scour which created the pool – potentially providing gravel-spawning species with an opportunity to breed.

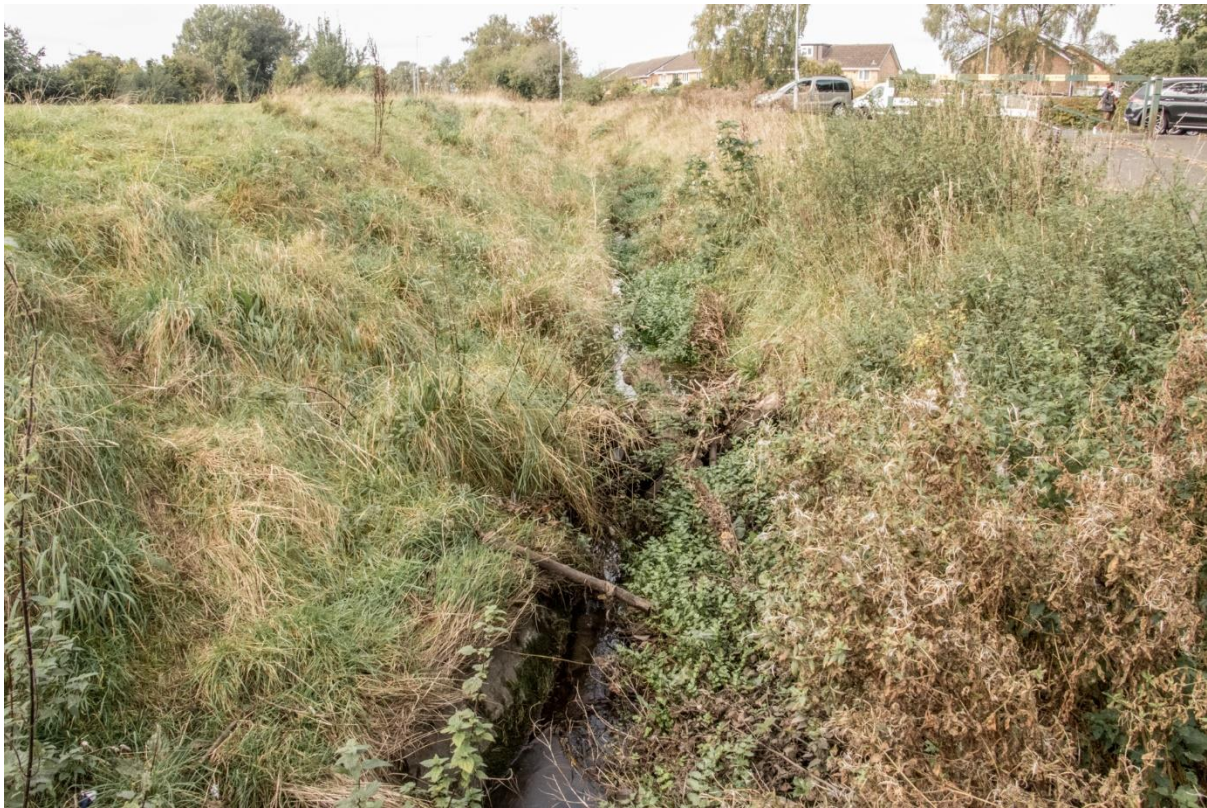
The heavily armoured/artificial riverbed channel downstream (Fig. 6) contains vegetation growth which is of concern to local residents. However, the incised nature of the channel below the level of the flood plain actually creates a large volumetric capacity.

Figure 6: Artificial channel with heavily rock-armoured bed. The straightened channel serves to divert the watercourse past residential buildings across the road from the RB.

As just one example of heavily-engineered channels noted during these visits, the biggest constraint on ecological quality is the completely straight, uniform channel which has little potential to create varied habitat structures. The land bordering the LB appears to have the space to accommodate a significantly more meandering channel. However, discussions around such river restoration work (which would also deliver flood-risk mitigation) appear to meet with resistance on the basis of costings.

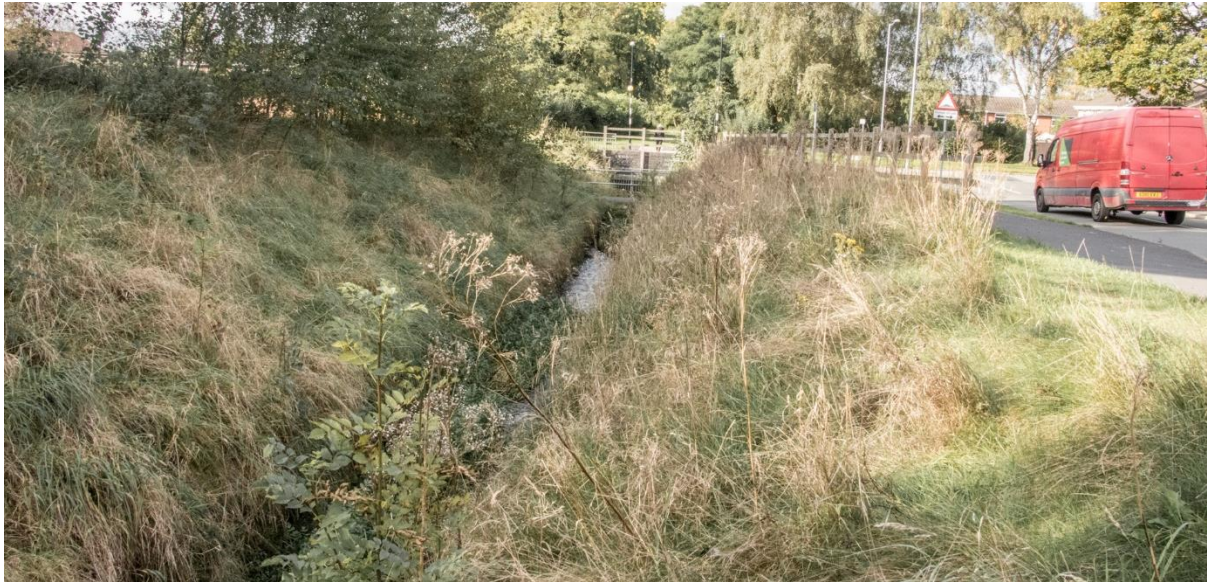
In terms of concerns over flood risk posed by in-channel and riparian vegetation, the presence of a trash screen covering the culvert entrance (and the culvert capacity itself) at the downstream end is likely to pose the most significant limitation on flood-water conveyance (Fig. 7). In addition, the extremely incised nature of the channel affords no opportunity for floodwater storage in the space available alongside the LB. Instead flood-flows are encouraged to race directly into the pinch-point of the culvert.

In addition, the housing on the RB seems likely to have been built over the historic course of the Penk. Consequently, during high rainfall, it is common in such scenarios for the surface water to attempt to follow that original pathway of the watercourse. Those elements are far more likely to be

significant factors in determining the risk of flooding of those adjacent properties than maintenance of a completely smooth, artificial drainage channel. Removing some of the material forming these steeply-incised banks would create flood storage capacity with a restored stream flowing through the middle. This would create significant local (and downstream) flood-risk-reduction benefits.

Figure 7: Trash screen and culvert entrance - note the diameter of the culvert relative to the "bank full" cross-sectional area of the incised channel. Re-meandering upstream of this culvert and simultaneously improving connectivity with the available floodplain would provide significant ecological benefits while reducing flood risk and creating a stream that is of high amenity value, rather than a ditch.

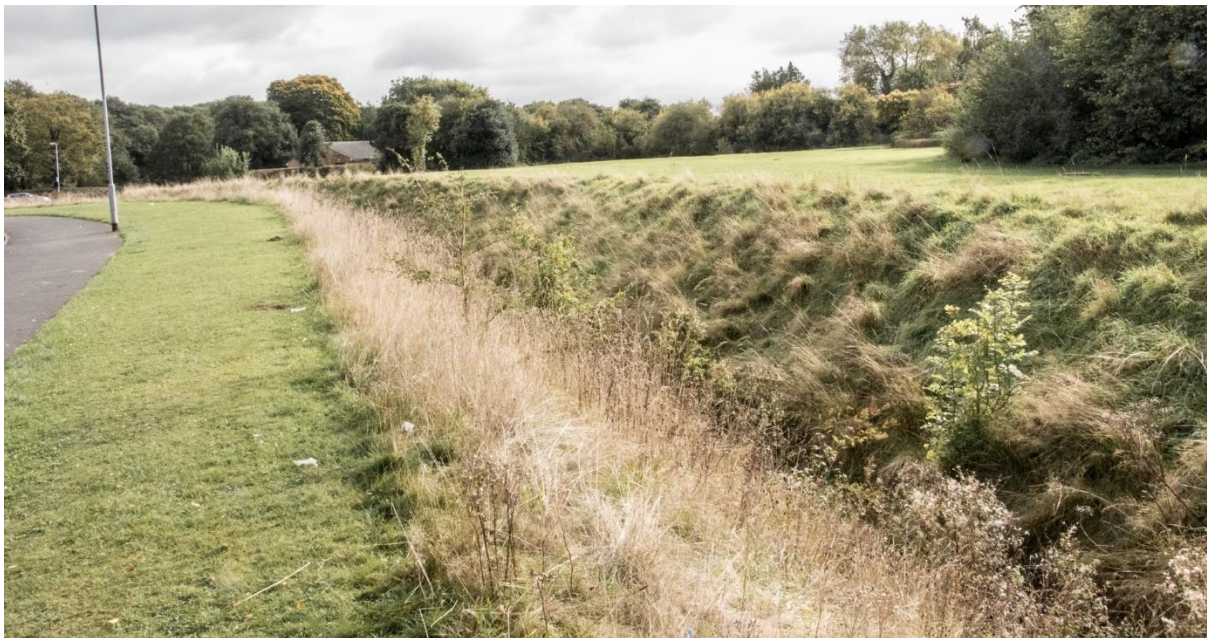
Figure 8: The grassed area pictured to the right of the channel (true LB) is potentially space available for re-meandering and floodplain re-connection opportunities.

- Relative influence of culvert capacity versus channel “roughness” and other factors to flood risk at this location
- Impact on return period of flooding for adjacent properties if the channel was re-meandered and re-connected with the (non-residential) flood plain adjacent to the Left Bank (Fig. 8)
- Overland flow pathways can be modelled to assist in quantifying flood risk to properties under each scenario

- Seek funding to objectively model and assess the costs and benefits of re-meandering (with improved flood-plain connectivity/floodwater storage) in the area shown in Fig.8.

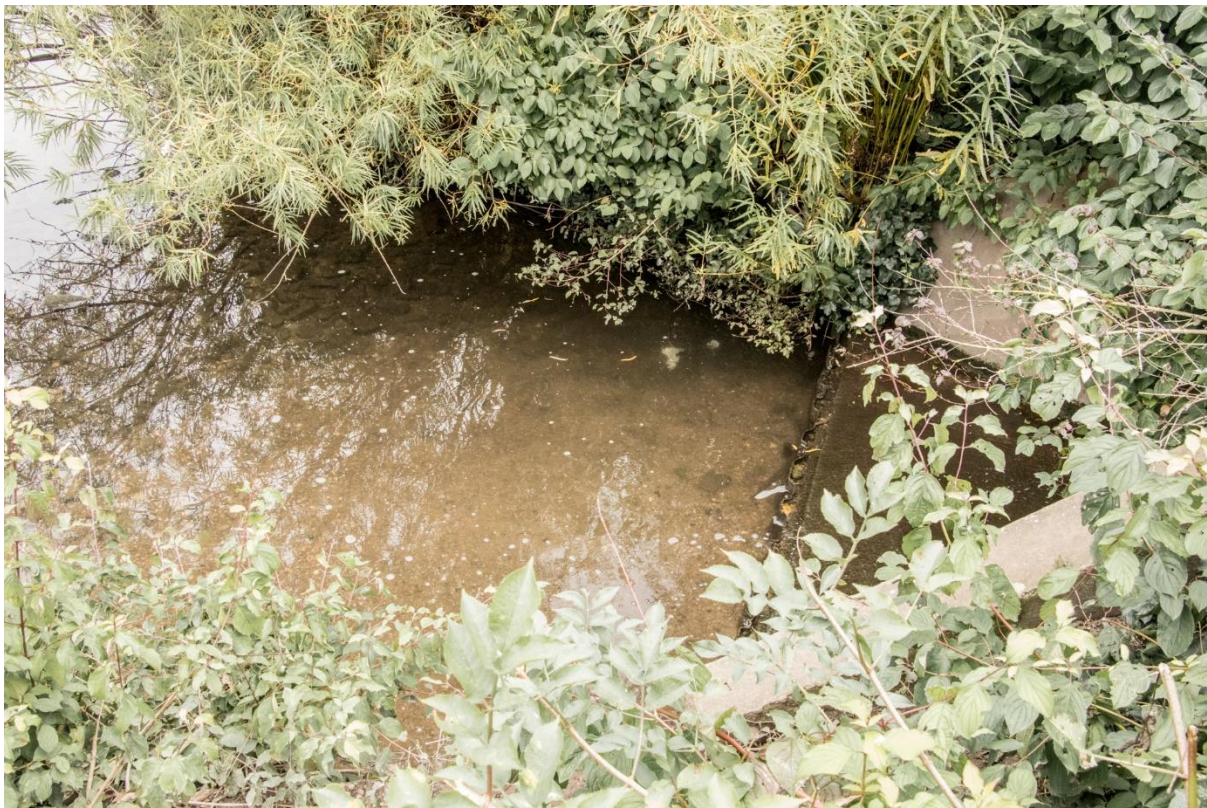
Figure 9: Lake inlet receiving the River Penk as it emerges from culverting.

Installing a kind of “mini rock-ramp” to mitigate this barrier may significantly improve longitudinal connectivity for fish. However, passage through the culvert would also need to be assessed in order to inform on the value and scale of any undertaking to improve fish mobility.

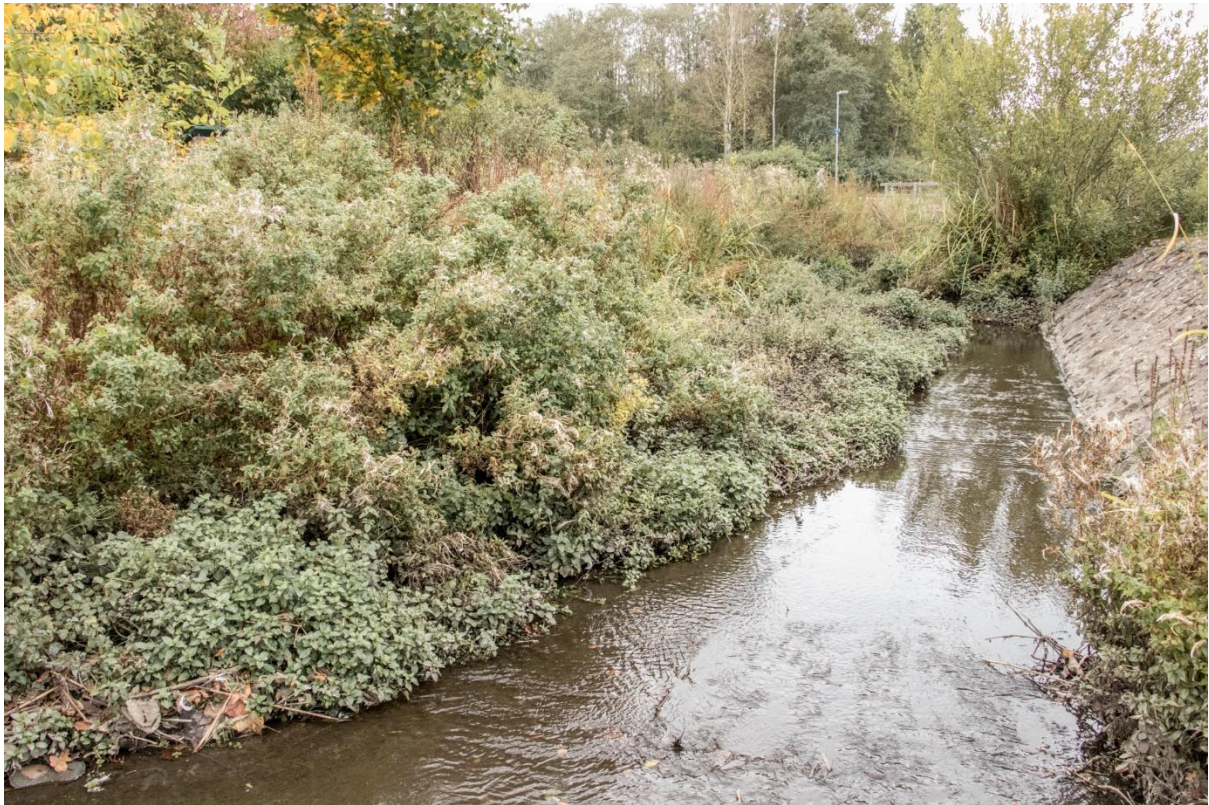
After skirting around the lake to the outlet, the concrete bed of the outlet channel was immediately apparent. The smooth, uniform surface provides very little opportunity for diverse communities of plants and animals to thrive (Fig. 10).

Figure 10: Just inches deep and flowing over a smooth, flat concrete bed at SO86129 99823 – very poor habitat for most stream organisms.

In the absence of the encroaching vegetation (Fig. 10), the situation would be even worse from an ecological perspective. Similarly, the re-colonisation of the channel since previous the Advisory Visit to this site (Fig. 11) is providing the main ecological benefit to a concrete drainage chute.

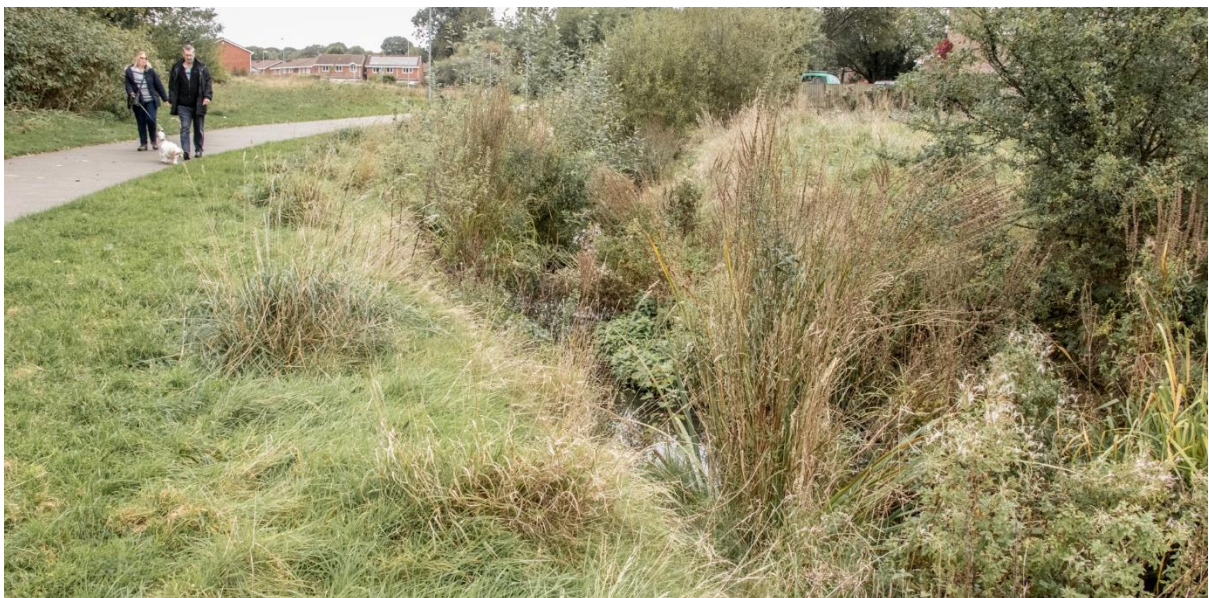
Figure 11: Vegetation recolonising the artificial drainage channel that forms the River Penk at SO 86091 99847.

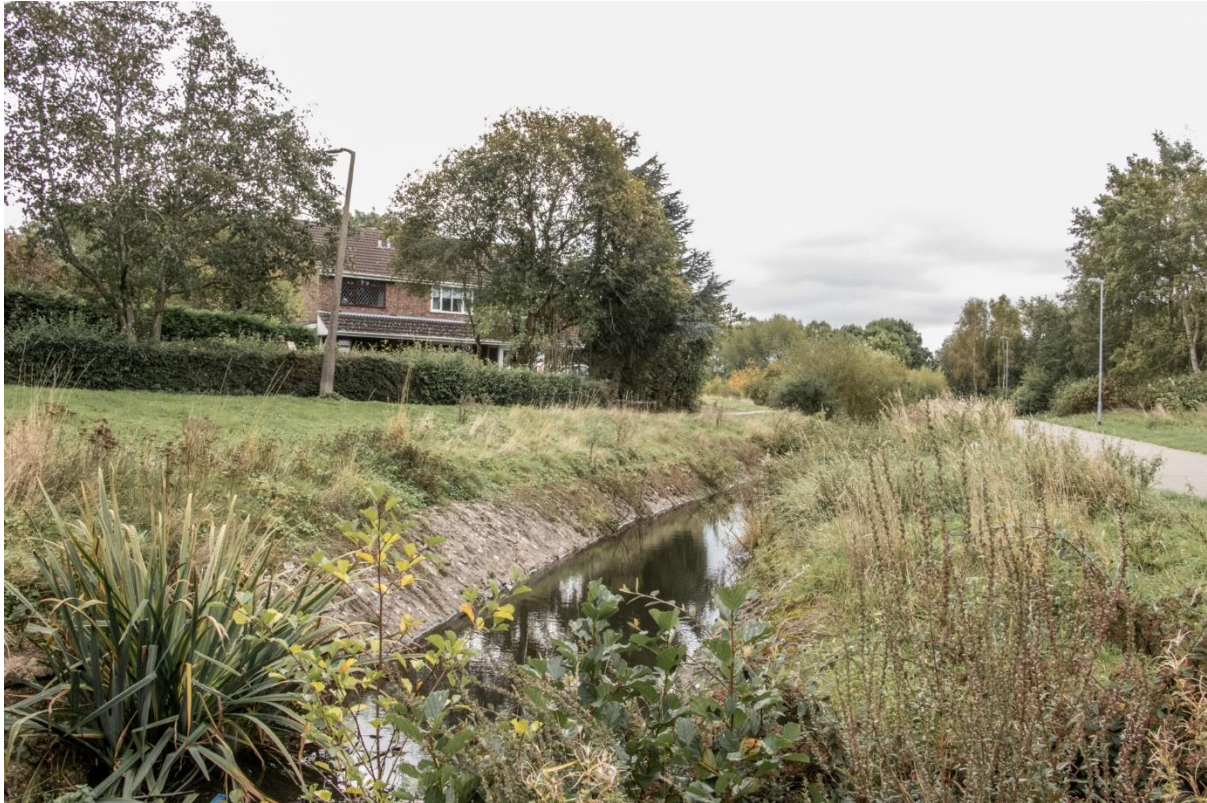
However, local opposition exists even to plants growing within the comparatively open stretches - such as those shown in Fig. 12.

Figure 12: More open section of channel - which still draws complaints requesting vegetation removal.

The above observation implies that interpretive signage to draw attention to the variety of plant species present (and the associated, dependant fauna) may help to provide an objective view of the ecological value of the Penk. However, the vegetation under discussion still exists within the context of a (physically) severely-degraded and artificial drainage channel. The natural limit imposed on biodiversity by straight, uniform, concrete channels cannot be ignored and any step-change in improved biodiversity would require significant stream restoration interventions. Investigations of what lies beneath the concrete bed would be a first step in breaking out that channel to enable a more natural and diverse channel to be formed.

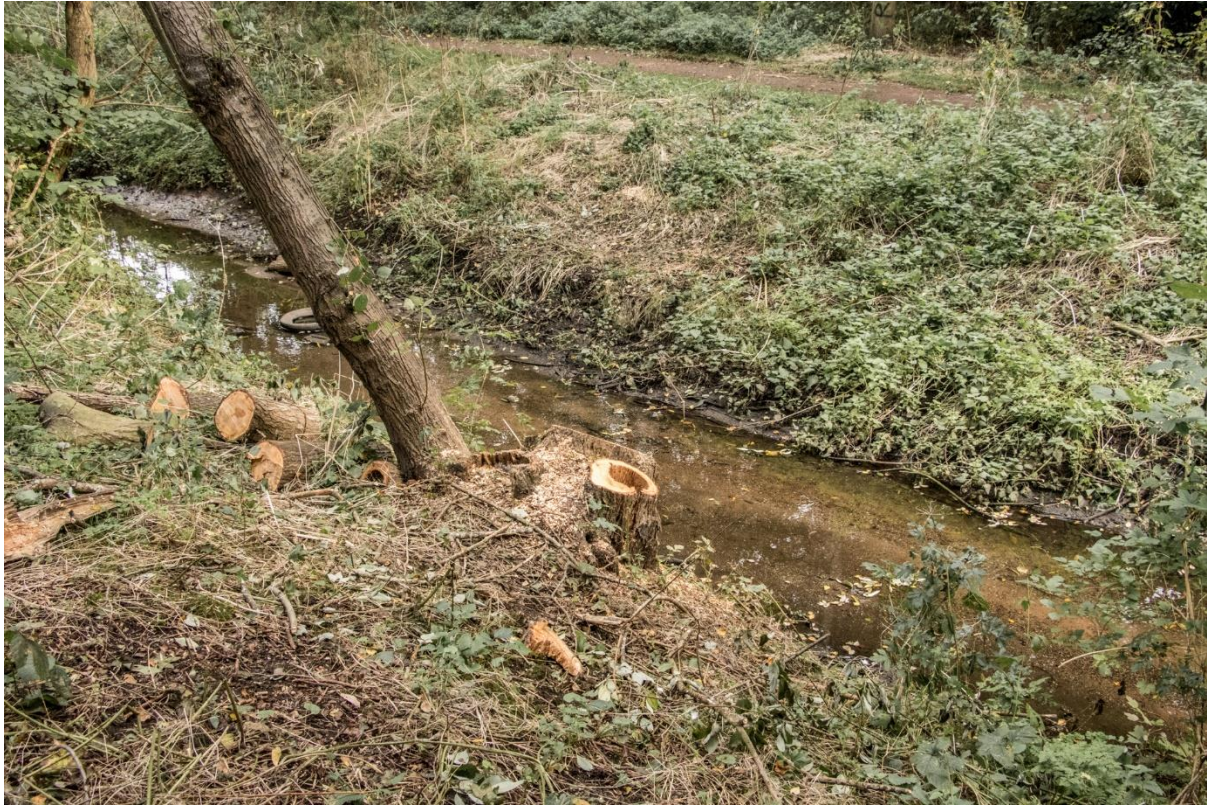
Although still forced to follow an artificial course downstream of the channel shown in in Fig. 12, there is a return to more natural substrate. In this area some light coppicing has been carried out (e.g. Fig. 13).

Figure 13: Coppiced riparian tree at SJ85935 00118.

Further diversification of the habitat in this reach could be achieved by laying coppiced trees at an angle across the channel. Keeping the thick end of the trunk on the bank (and if necessary anchoring to its stump) and wedging/keying the crown end into the opposite bank would be a useful mimic of natural, stable dead-fall. The angled gap below the trunk would encourage localised bed-scour and increase the structural variation in the habitat. Ensuring that trees lay at a slight downstream angle would favour material deposition at the downstream end of such structures. This helps to avoid the gap beneath the trunk from becoming blocked.

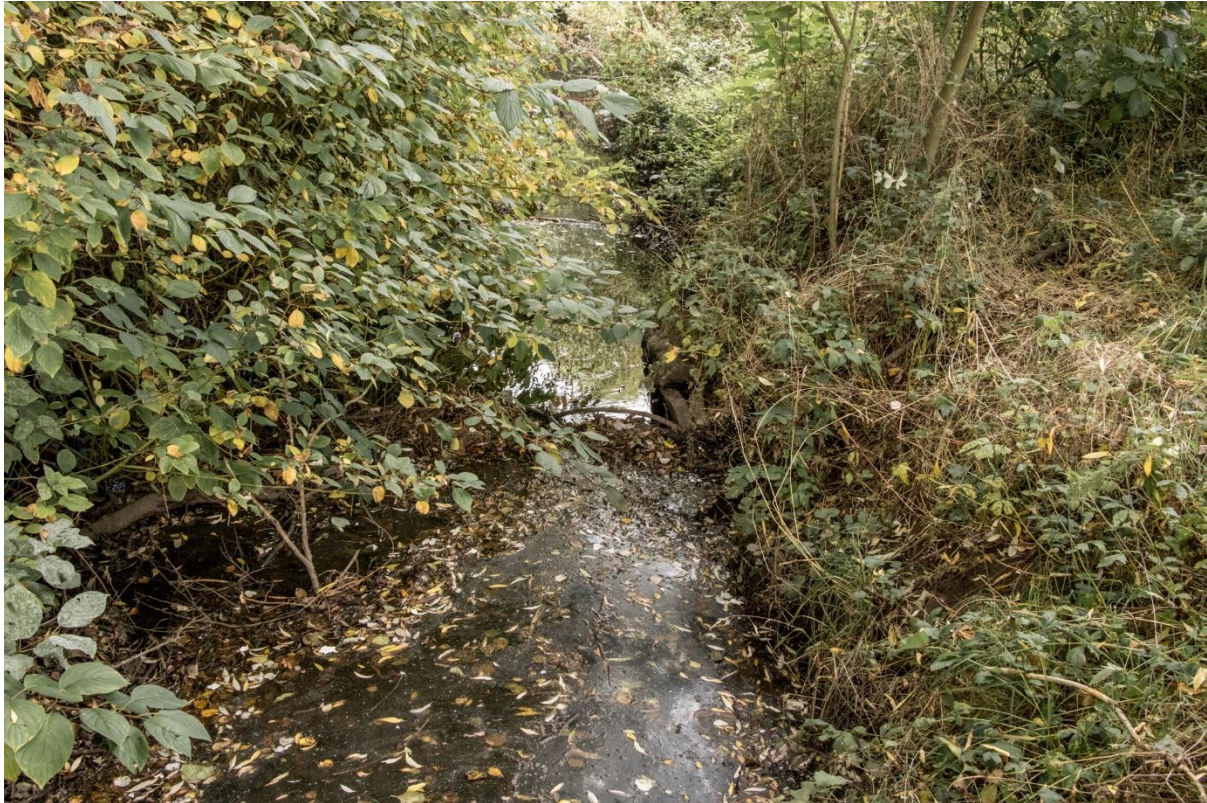
topographical contour lines. Alternatively, flow may be impounded downstream and simply “backed-up” to the lake outflow. Consequently, there is an almost complete lack of gradient to support flowing water habitat during most conditions (Fig. 14). In the absence of possibilities to return the channel to a more natural course and remove impounding structures, these completely still sections are best treated as part of the adjoining lake habitat.

Figure 14: Almost no flow at normal water levels – essentially stillwater habitat.

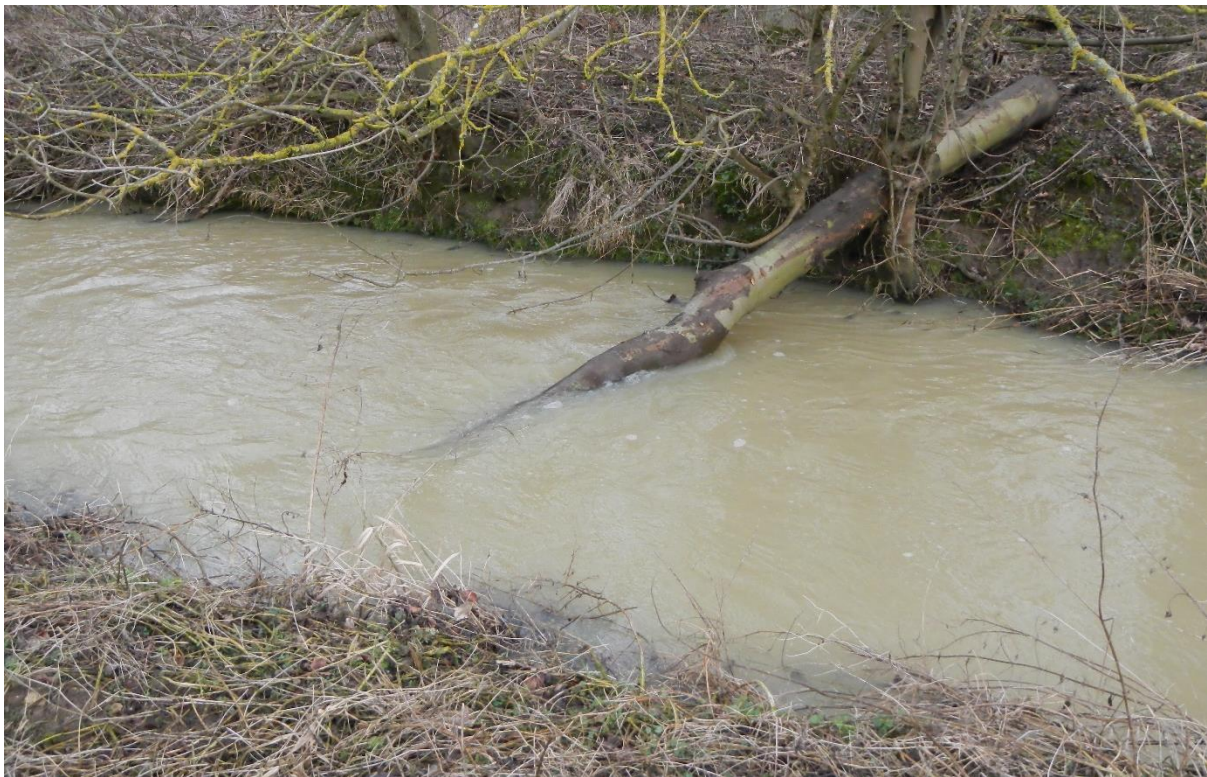
Figure 15: A lodged cross-channel log to mimic natural dead-fall shown in spate conditions. Note the gap between the riverbed and the underside of the log for the majority of the trunk.

- Consider retaining and using coppiced material to mimic large woody material deadfall habitat (e.g. Fig. 15)
- Investigate opportunities to improve longitudinal connectivity between lake, culverted and open sections of the upper Penk
